# HARRAWAY TREE SERVICES

## TREE INSPECTION REPORT

**Client:** Tree Solutions, for clients  
**Location:** St. Nicholas's Churchyard, Hurt, Berkshire  
**Date of inspection:** 27 October 2008  
**Inspected by:** J.Harraway FArborA, MICFor

**Our reference:** TIR/1108/5

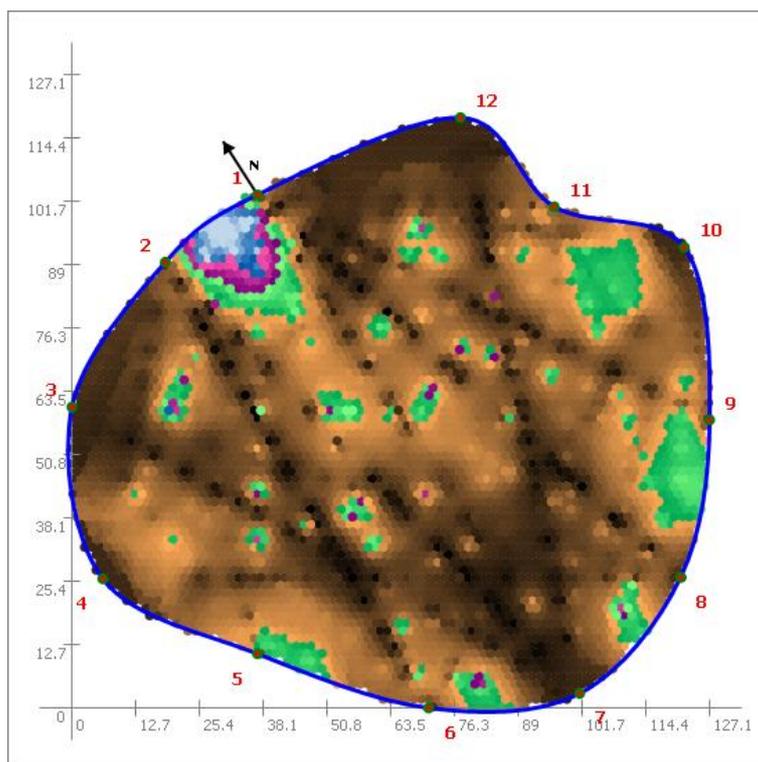
The first Picus investigation, at a height of approx. ten centimetres above ground level, produced the following tomogram. Twelve measuring points were used, with sensor 1 placed on the north side of the stem.

A small area of established decay is indicated clearly on the north side of the stem, between sensors 1 and 2 (coloured blue/red). Other green mottled zones are dispersed across the stem. The inference of these is covered in the next section of the report. Photos of the fungal fructifications are shown below:

The tomogram at the base of the stem appears to indicate an area of decay between sensors 1 and 2, on the north side of the stem; this corresponds to the position of the fungal fruiting bodies. This indication is also represented on the first Resistograph drill trace, which records low drilling resistance to a depth of some 20cm. In actual fact, the fungus is developing from an area of compressed bark between root buttresses and I consider it likely that it is this zone of included bark that has led to the results.

The small green zones dispersed across the stem are perhaps more significant. These result from lowered sonic velocities between a number of different measuring points, but are not concentrated in one area, as has occurred in the small zone on the north of the stem. This affect has been noted by many users of the Picus instrument when *Kretzschmaria* is present, although the reason for the effect is not fully understood.

I have sought the opinion of two other colleagues, Frits Gielissen and Dr. David Furner, who are both engaged in research into decay and its detection (in the Netherlands and Germany respectively). I sent the Picus data to them for analysis and comment (with all details of location and client removed) and received a reply which suggests that they consider the tomogram indicates the presence of deterioration due to the fungus.

- *The investigation with the Picus has provided some evidence that Kretzschmaria is present across the stem, but the results do not evaluate its significance or predict when failure may occur*
- *It would be prudent to significantly reduce the crown of the tree as soon as practicable, and monitor its condition, or remove and replace it*

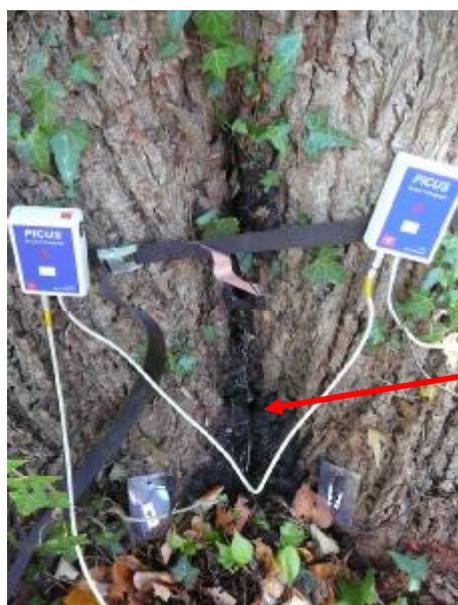
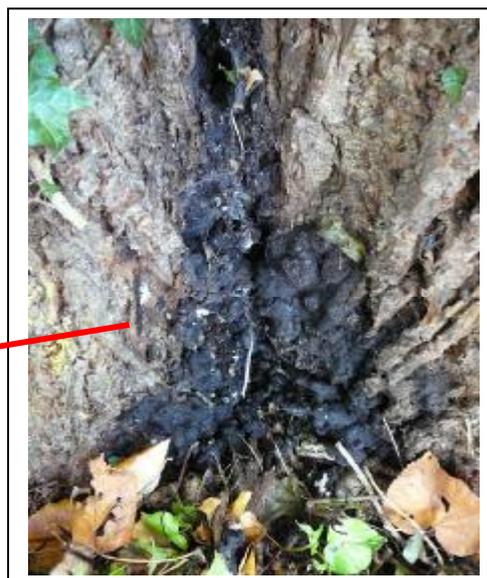
Recent removal of thick sucker growth around the base of the stem has revealed the presence of a black crust-like fungal fructification, on the north side; this undoubtedly indicates infection with *Kretzschmaria deusta*, an organism not infrequently present in mature trees of this genus. See photos on page three of the report.

The fungus identified at the base of the stem, *Kretzschmaria sp*, causes a brittle decay that is notoriously difficult to detect and evaluate, even using modern technologies. The fungus can lead to sudden breakage of the stem, in extreme cases, without any external growth response by the tree (the presence of decay can, in some instances, cause trees to produce extra wood around weakened areas to compensate for loss of strength).

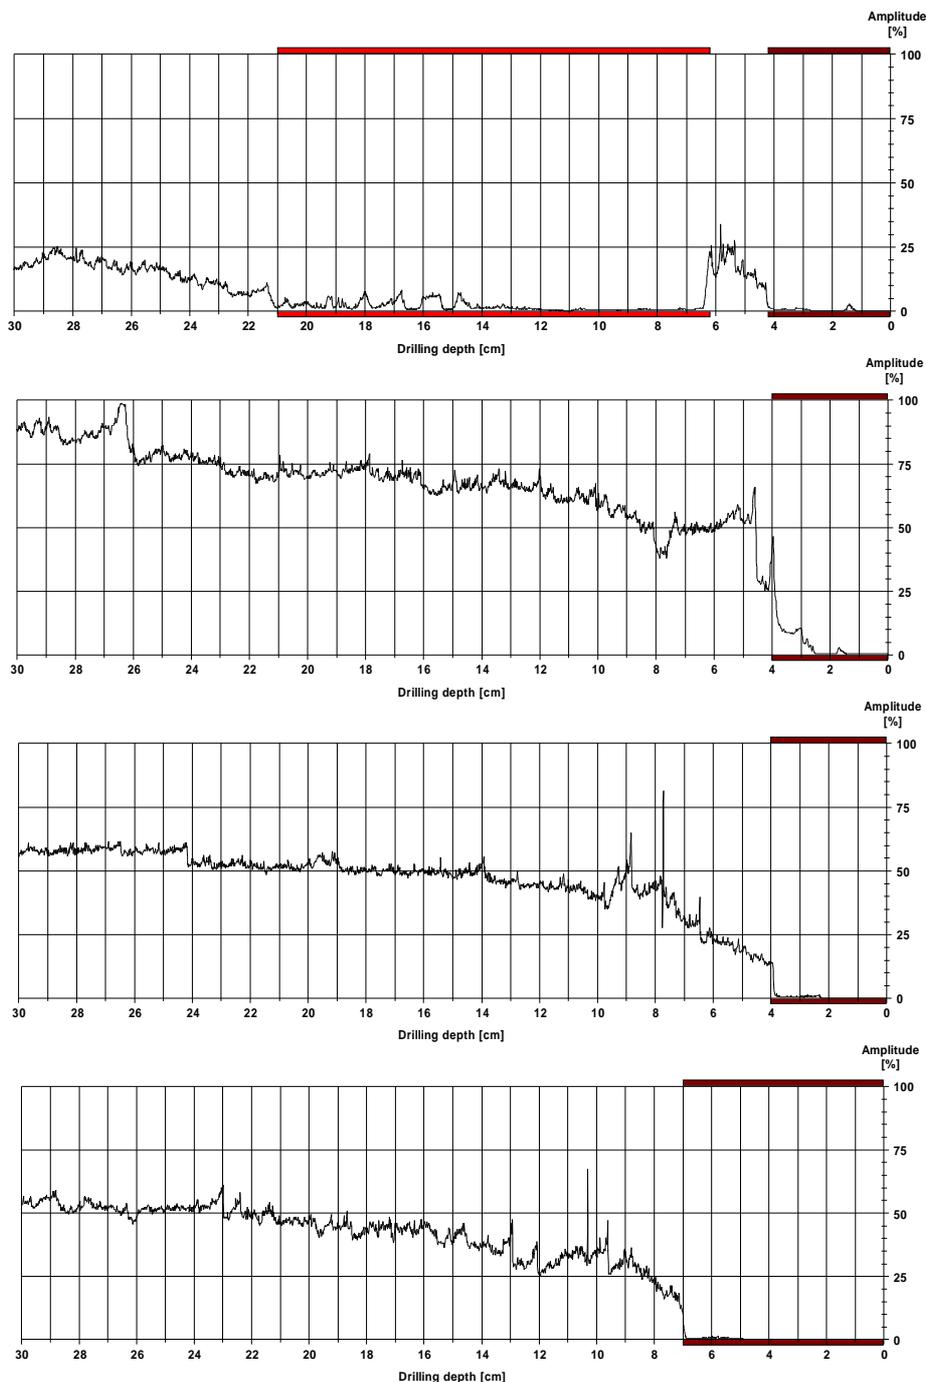
To provide additional information about the condition of the lower stem, the Resistograph was used at the same level as the Picus, in the following locations: adjacent sensor 1, between 5-6, 8-9 and adjacent 11. The drill traces recorded are shown below in this order:

Apart from the first drilling position, none of the Resistograph drillings records any distinct drop in drilling resistance. This is not anomalous to the presence of this type of decay.

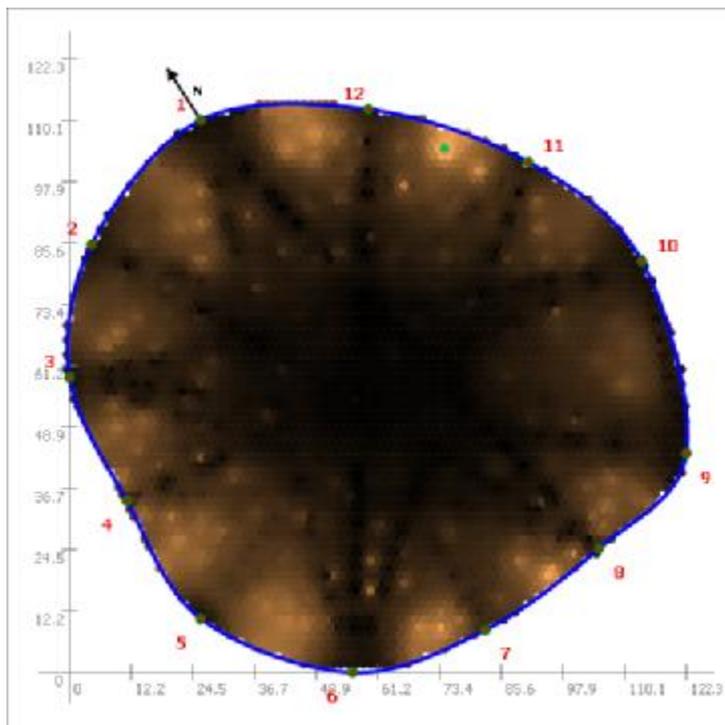
The Picus was also used beneath the large stem wound at 2.5 metres, to assess whether decay extended beyond the visible extent in the cavity.

No decay is indicated at this level. A photo of the wound and assessment level is shown below:

The second tomogram, at a higher level on the stem, shows no indication of decay across the stem. Accordingly, I consider that any decay in the old pruning wound is relatively confined at present.
